**ADDENDUM NO. 2**  
**July 2, 2026**  
**City of Boise, Department of Aviation**  
**Request for Proposals BOI**  
**Hangar Building and Ground Lease Opportunity RFP**

# ASBESTOS MANAGEMENT PLAN

## FORMER SIMPLOT AVIATION BUILDING

# LEAD-BASED PAINT MANAGEMENT PLAN

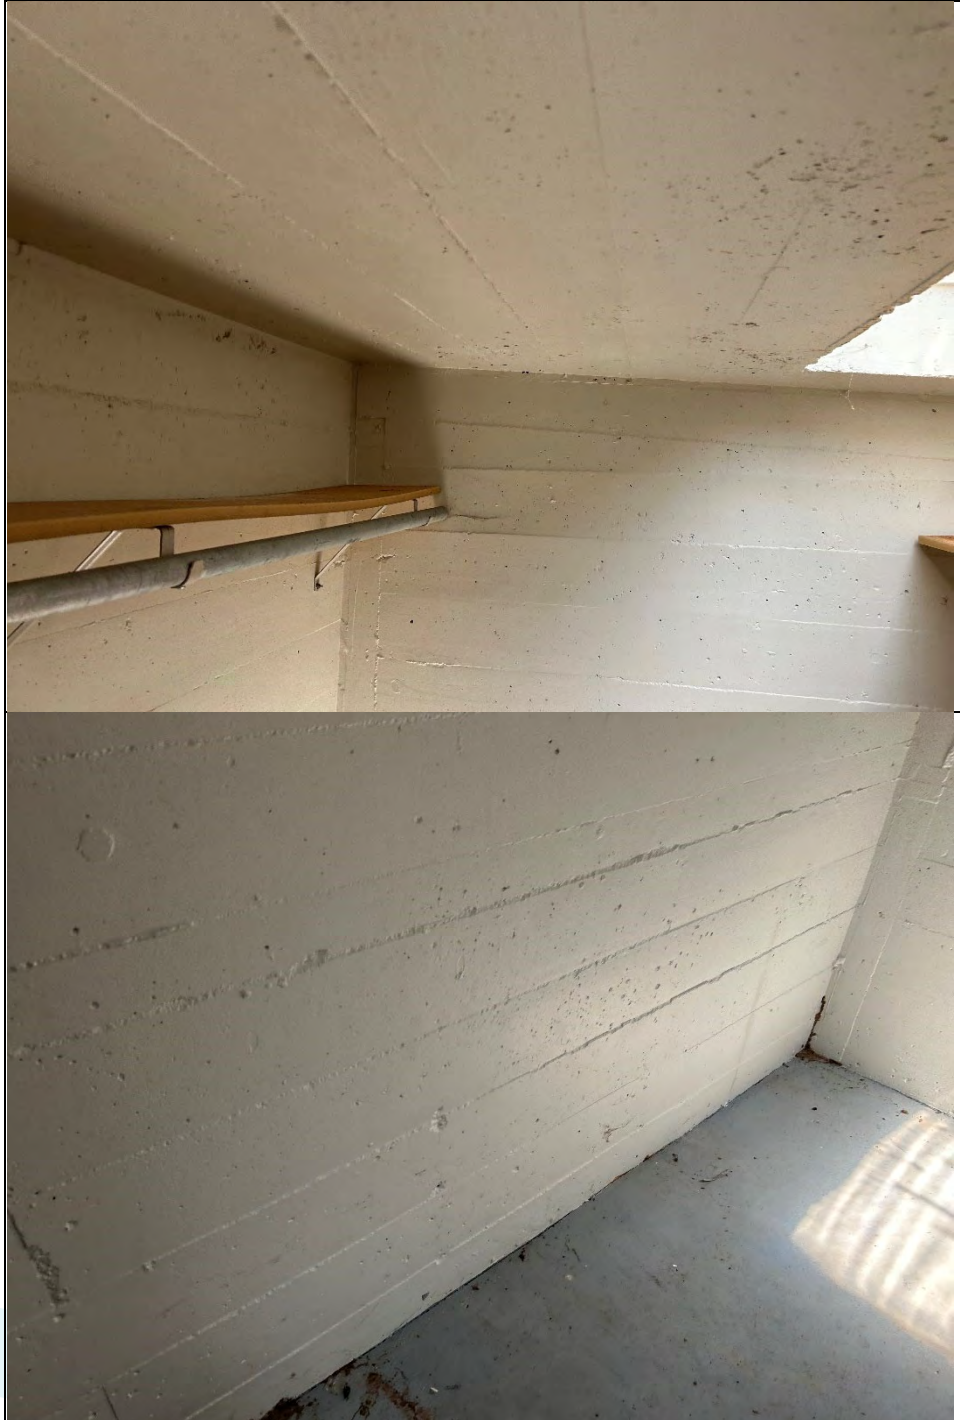
**Lab sample number**  
0048153-043 through 0048153-045

**Material/Location**  
Concrete Walls and Ceilings – Coal Room

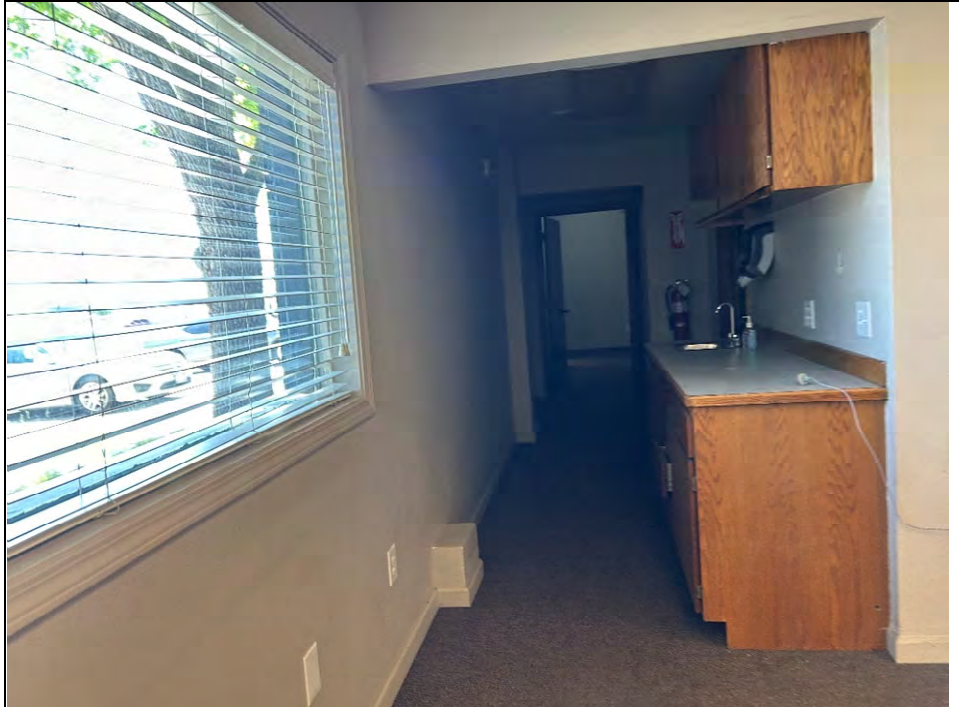
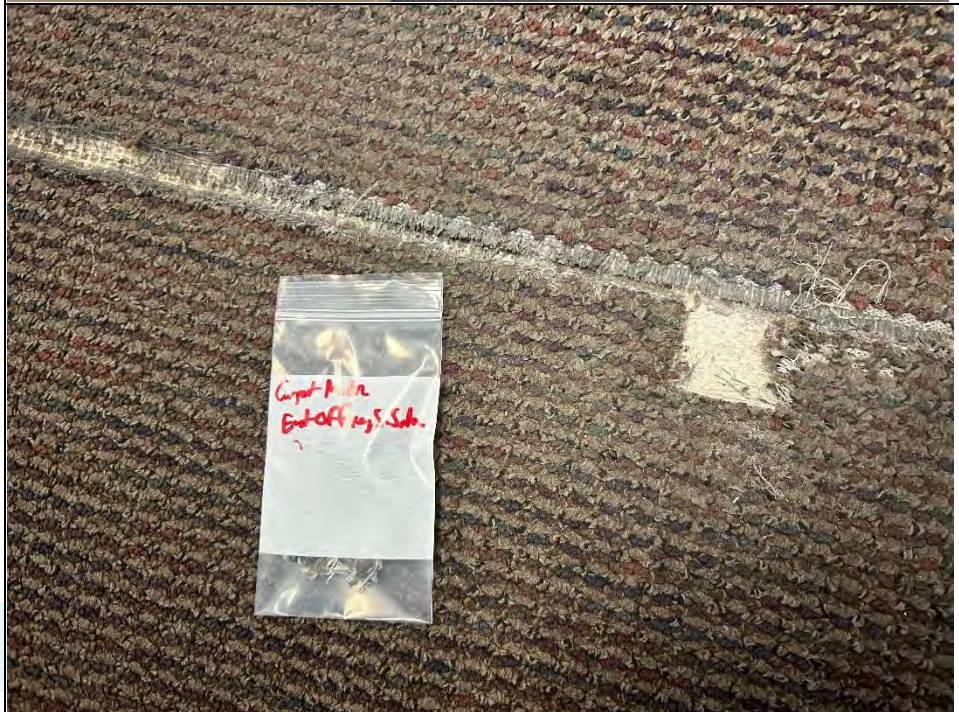
**Lab sample number**  
0048153-052 through 0048153-054

**Material/Location**  
Carpet Mastic – Office Spaces

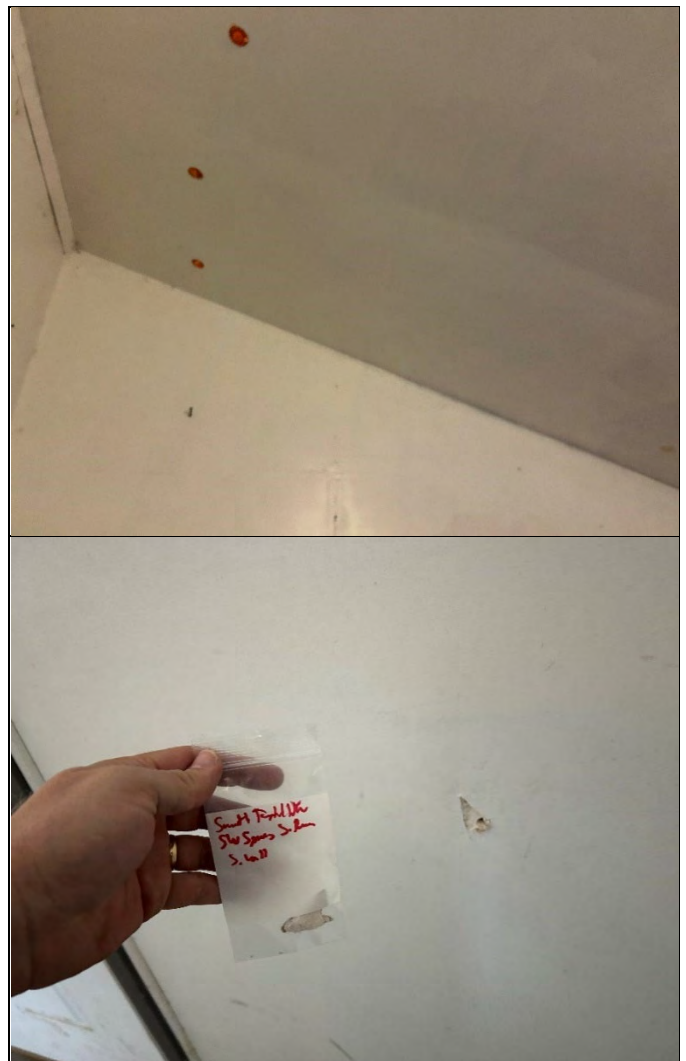
This ACM is described as being non-friable and in good condition with minimal damage. The potential for disturbance of this material is high due to the location the material being in a high traffic area.

The recommended response action is to maintain in good condition. If during periodic surveillance or re-inspections material is identified in deteriorated condition, the response action shall be revisited, and appropriate action (removal, enclosure, or encapsulation) shall be implemented.

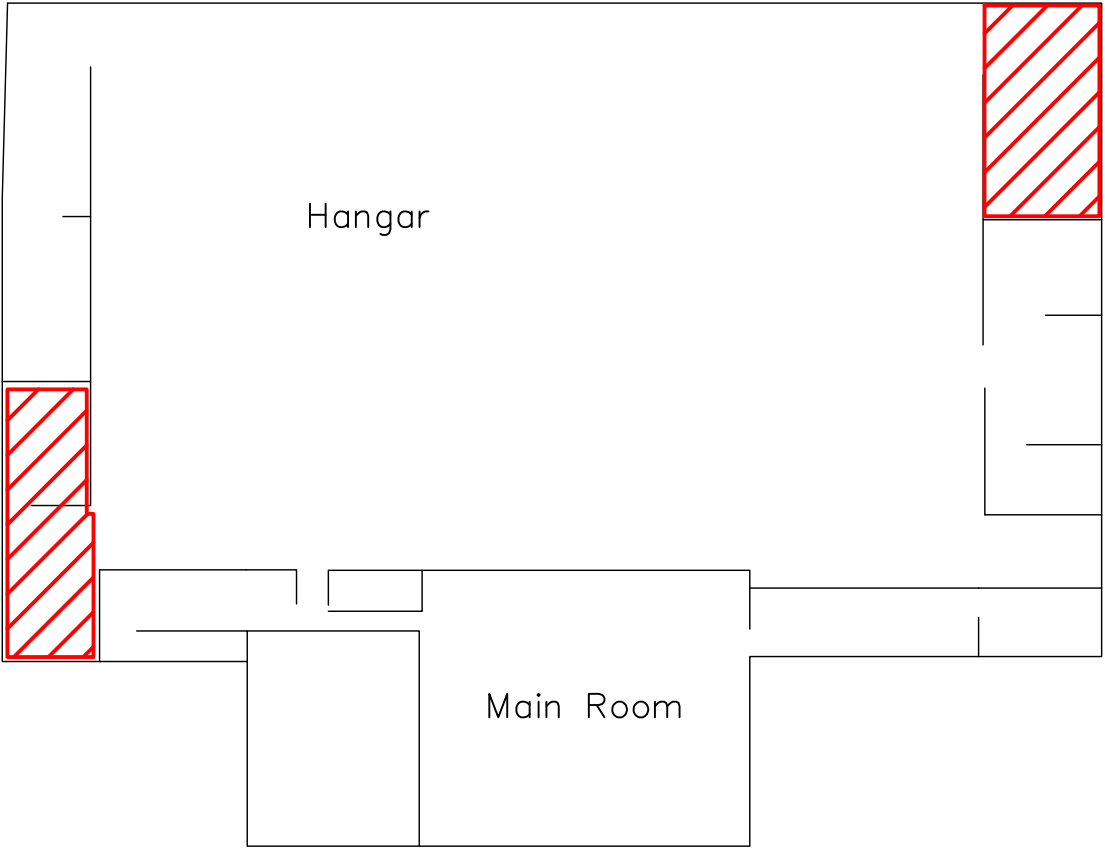
Positive ACM: Joint  
Compound  
Associated with  
Smooth Textured  
Drywall

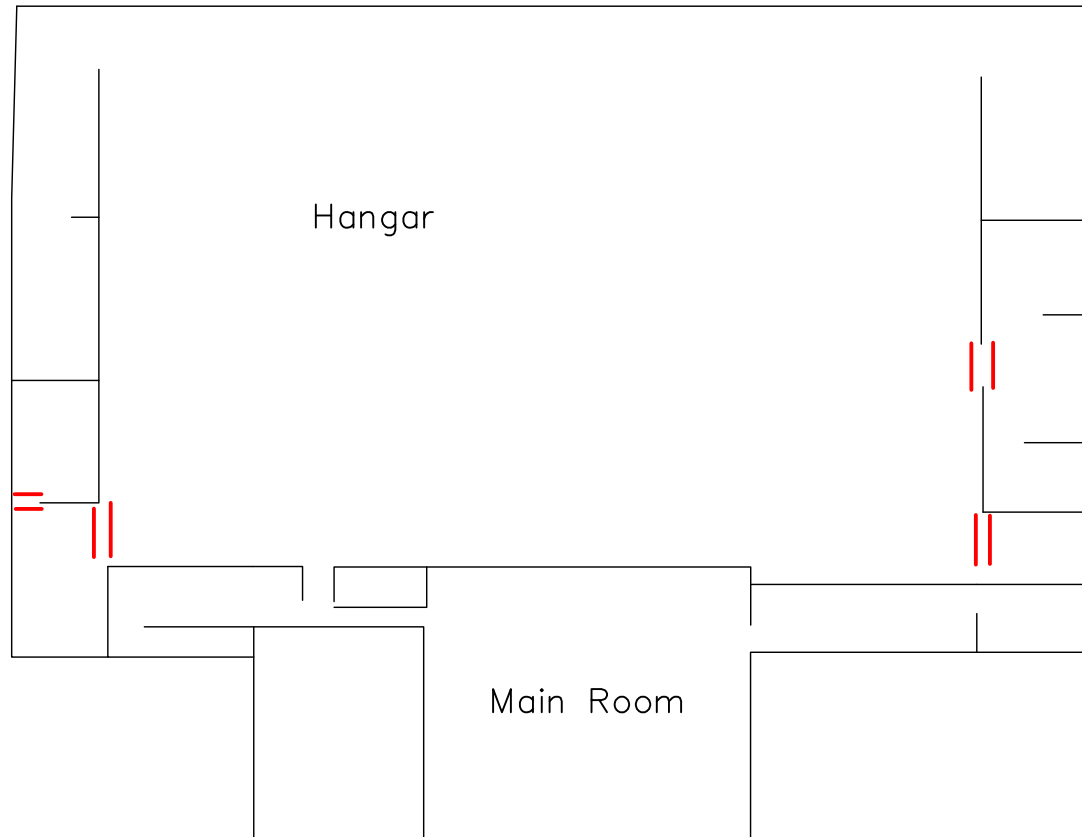
Positive LBP
